On August 1, 2018 an unauthorized discharge of diesel fuel occurred in the Florida Avenue Canal nearby the Alvar Street culvert in Orleans Parish. The discharge originated from two above-ground storage tanks located within the abandoned Naval Activity Support facility currently owned by the City of New Orleans. The source site is not permitted to discharge any substances to the waters of the state, a violation of La. R.S. 30:2075 and La. R.S. 30:2076(A)(1)(a). Five black-bellied whistling ducks and two turtles were observed to be impacted as a result of the unauthorized discharge, a violation of LAC 33:IX.1113.B.1.d and LAC 33:IX.1113.B.5. There were no reports of human injury, fire or road closures. BGL

**SUMMARY OF DIESEL SPILL
FLORIDA AVENUE CANAL
AUGUST 1-9, 2018
FINAL REPORT**

E.A.D. INVESTIGATOR'S REPORT

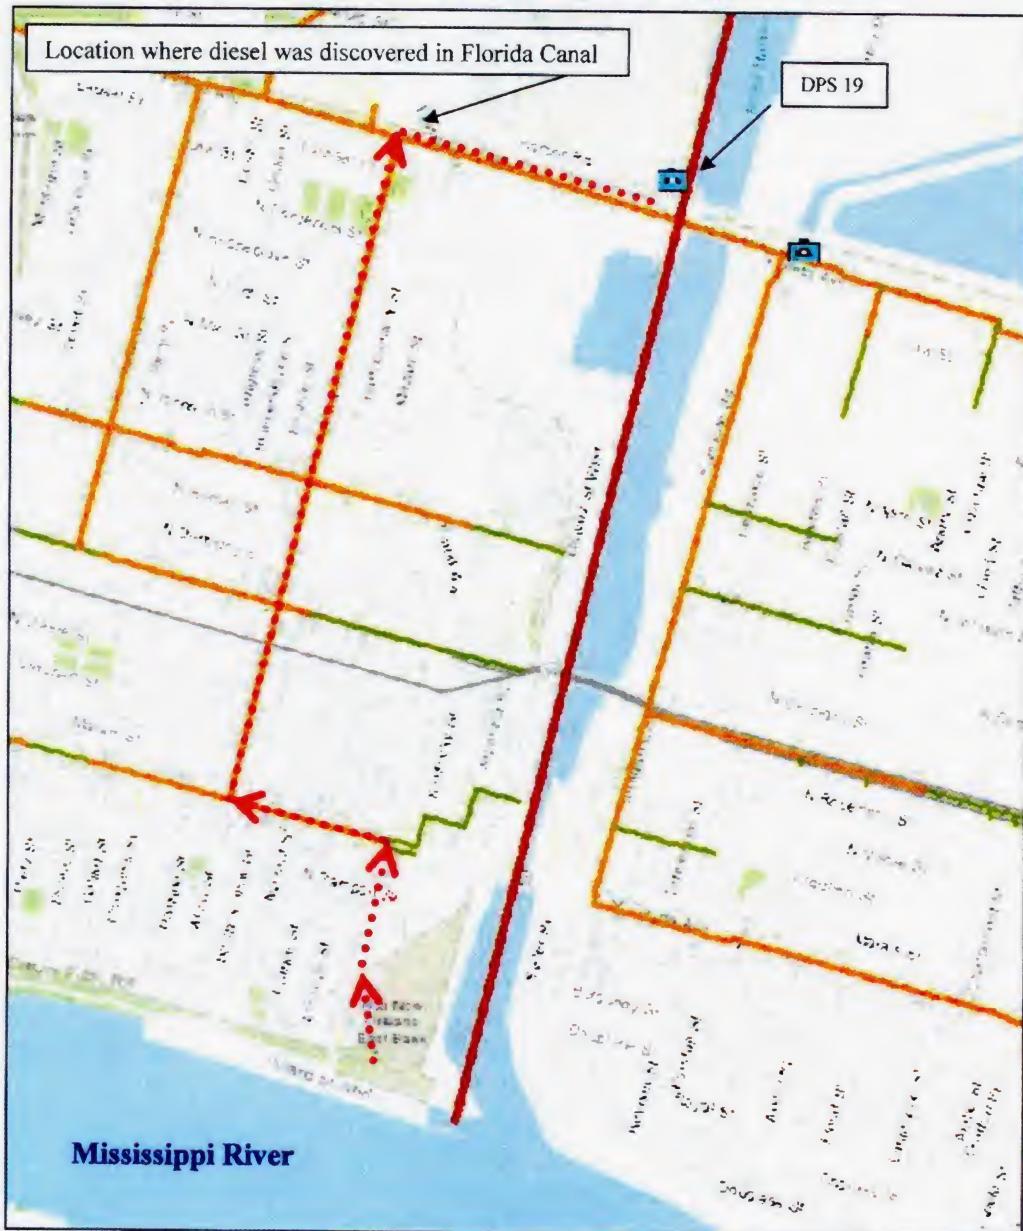
Diesel Spill Path in Drainage

- DATE: 8/1/2018 – 8/9/2018
- LSP Incident No. 18-03596
- National Response Center Incident No. 1220212
- Complaint # 721
- SITE: Source of spill was at the abandoned Naval Activity Support facility, 603 Poland Avenue, New Orleans, LA. Diesel flowed through the drainage system North along Poland Avenue, West along St. Claude and North along Alvar Street where it was discovered in the Florida Canal and made its furthest reach to the DPS19 forebay.
- COMPLAINT: Diesel in Florida Canal
- COMPLAINANT: Boh Bros., Scott Belsom, 504-232-4020
- INVESTIGATORS: Scott Finney, Walter Berard, Eddy Schneider, Corwin Washington and Mary-Alice Sandberg

••••• Path of Diesel in Drainage

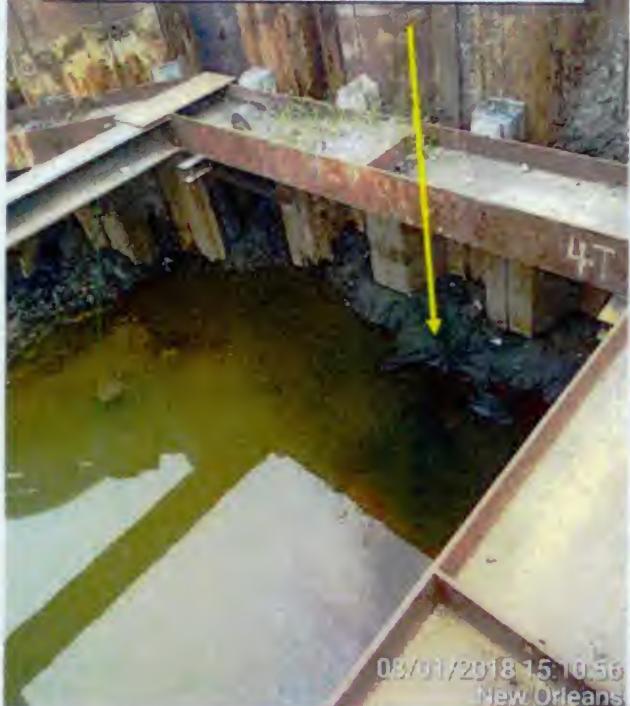
Outfall of Alvar box culvert into Florida Canal where the diesel made its first appearance

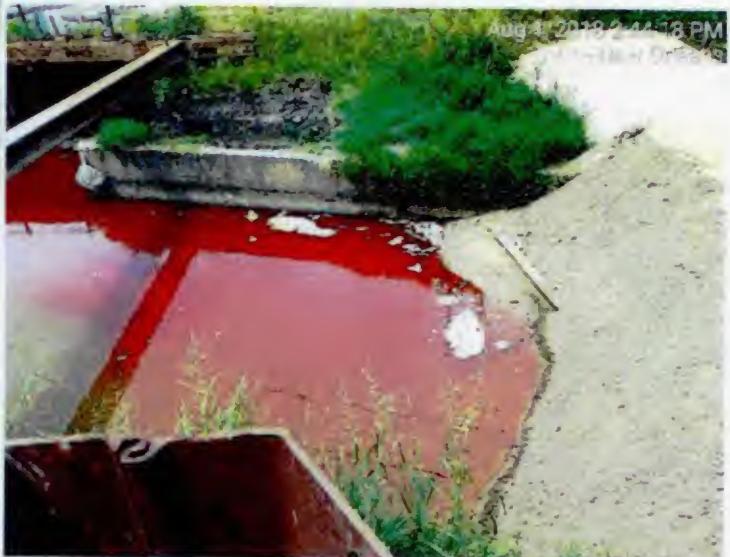
Diesel pooling at Boh Bros. sand dam

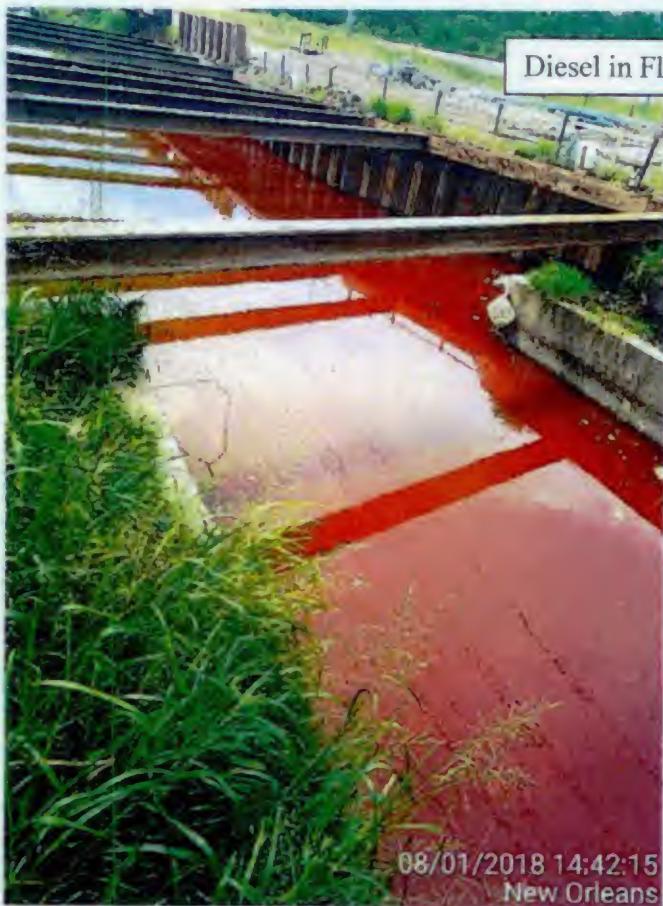
Diesel in Florida Canal

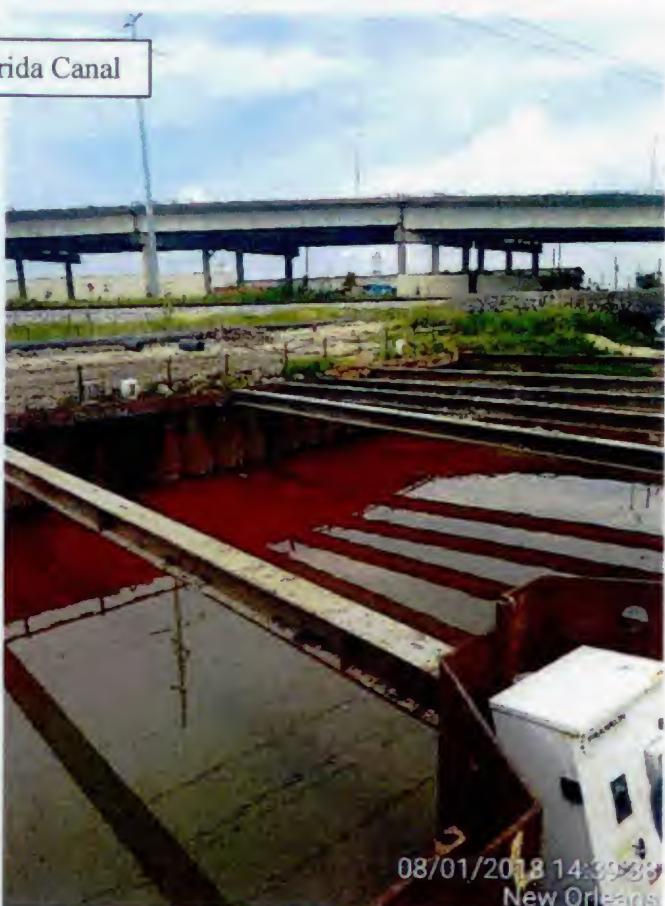
Florida Canal downstream from affected area. No signs of diesel on canal.

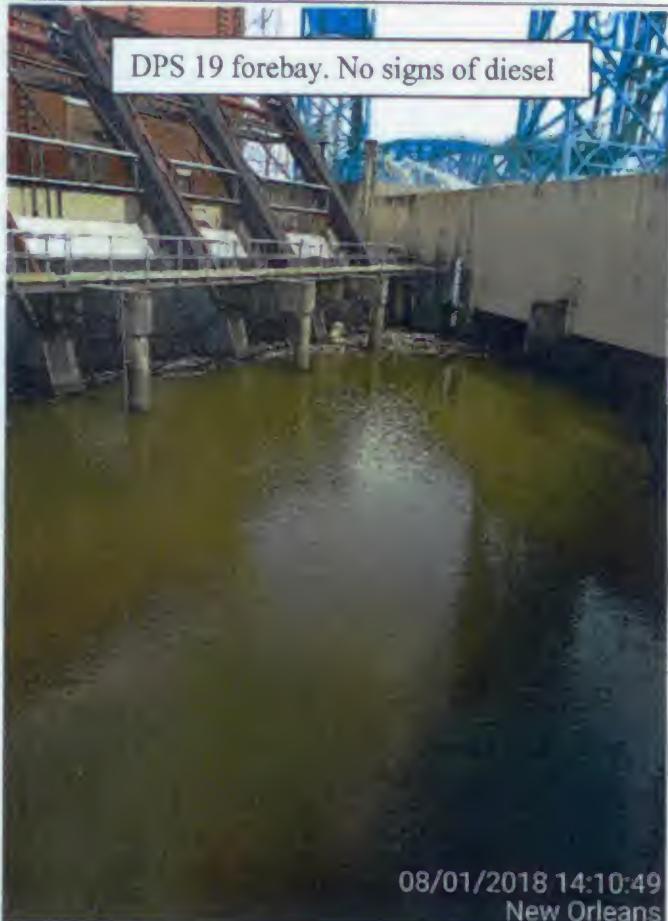
DPS 19 forebay. No signs of diesel

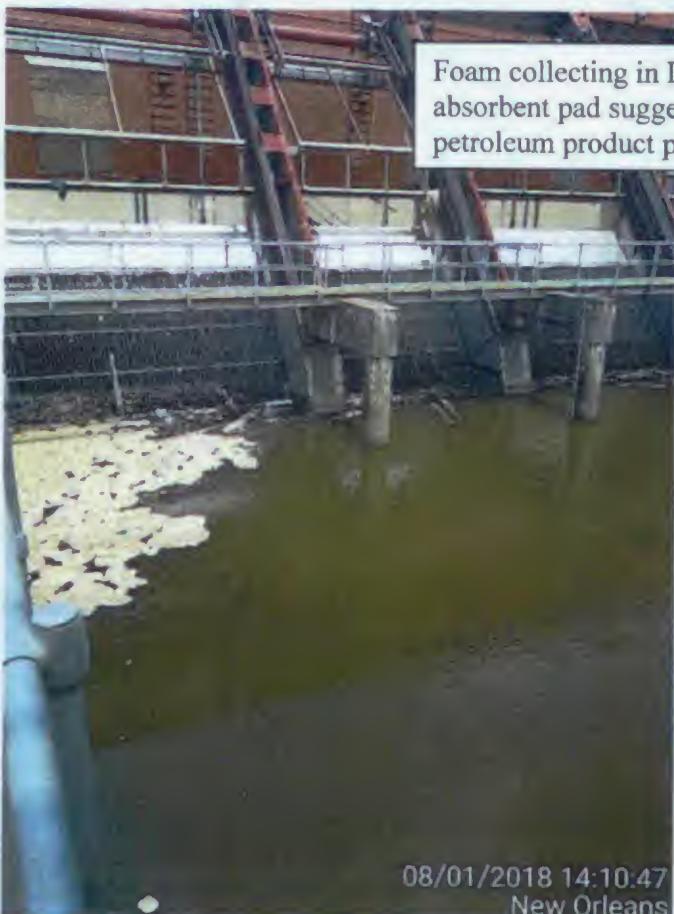
Foam collecting in DPS 19 forebay, oil absorbent pad suggested there was no petroleum product present

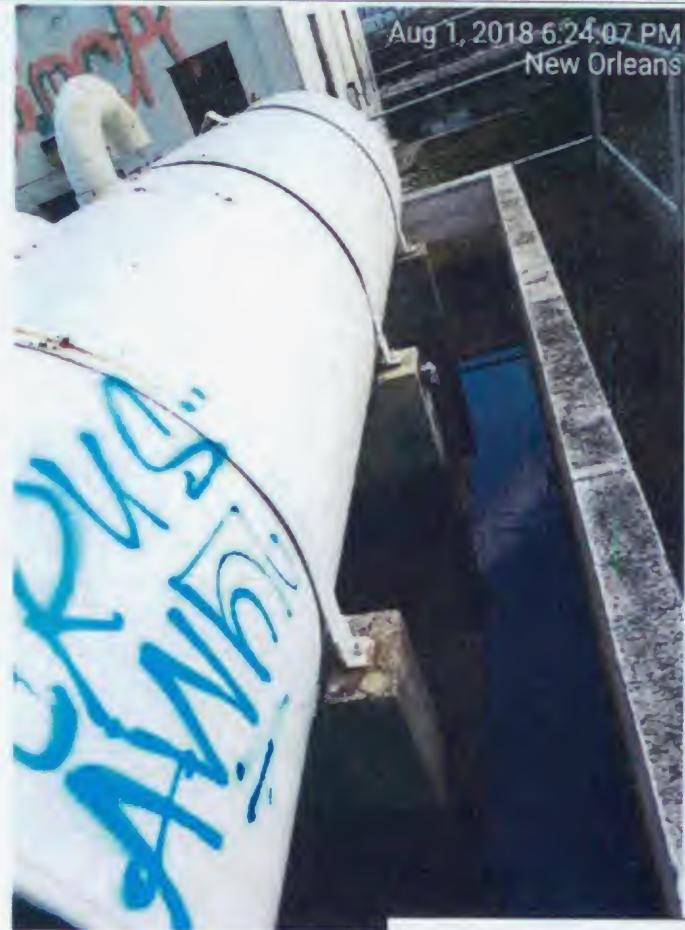
Trespassers scrapping material from the abandoned Naval Base on Poland Avenue removed brass plugs from the bottom of two roughly 2000 gallon storage tanks which emptied their contents into non-watertight secondary containment, then into the drainage system and eventually to the Florida Canal and Drainage Pump Station 19. None of the product was discharged past the drainage pump station.

At approximately 13:00 on Wednesday, August 1, 2018, the Boh Bros. construction crew on the Florida Avenue Canal reported a diesel spill in the canal from the Alvar Street box culvert. Corwin Washington and Eddy Schneider of SWBNO Environmental Affairs Department arrived to the site around 14:00 to begin the investigation. They met with Boh Bros., NOFD HazMat, DEQ Emergency Response and US Coast Guard. The diesel was contained by a sand dam the contractors had in place for construction. After confirming that the diesel did not originate from a spill on the construction site, USCG investigated the Alvar box culvert watershed for any above-ground signs of a diesel spill. Corwin Washington and Eddy Schneider investigated the drainage system to track down the source, they were assisted by Scott Finney and Walter Berard of SWBNO EAD and Walter Diamond of OMI. The crew identified the source of the leak to be from two above-ground storage tanks inside the abandoned Naval Support Activity facility on Poland Avenue. The drain plugs on the diesel storage tanks were removed, which caused the leak and the secondary containment for the

Diesel in secondary containment at source site

12. LA State Police and the National Response Center. See information in No. 2.
13. City of New Orleans, 1300 Perdido Street, New Orleans, LA 70112.
14. The incident could have been preventable if the diesel fuel had been removed from the above ground storage tanks.

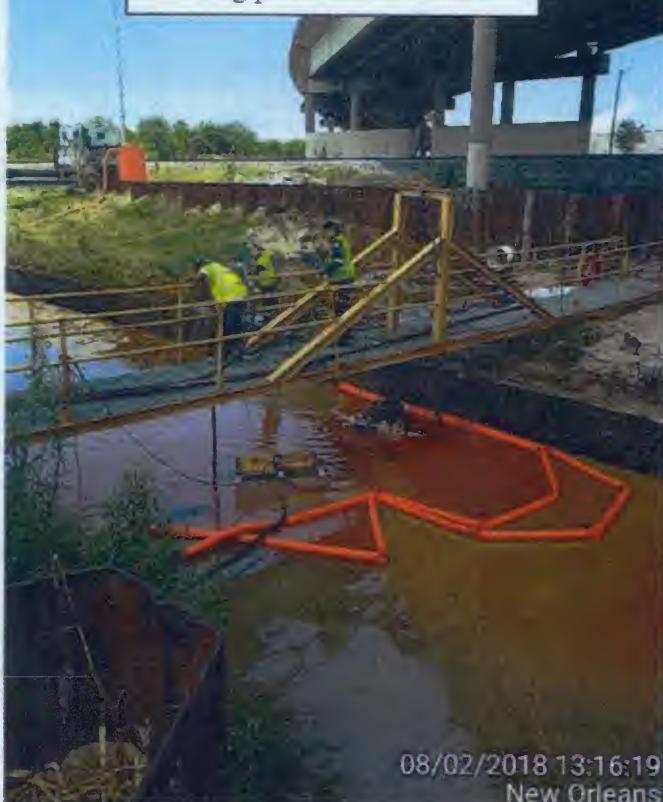
Drum skimmers and vac truck
cleaning product from canal

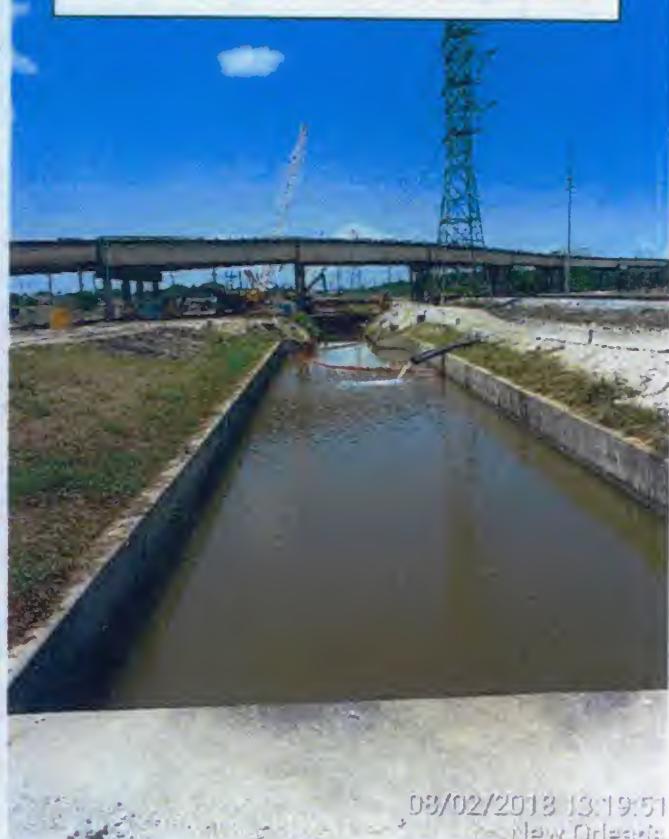
Florida Canal downstream of affected area

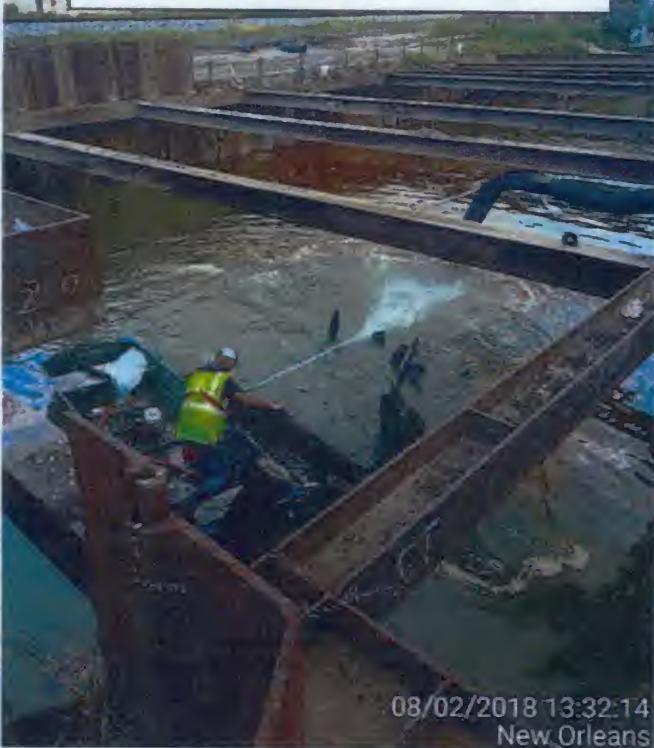
Diesel being herded in the canal by a
hose to facilitate the drum skimming
process

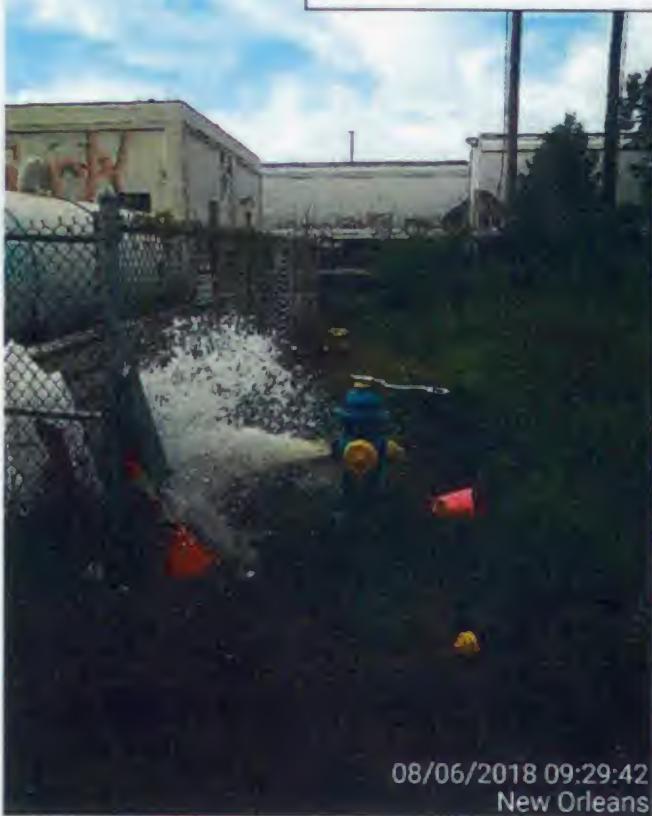
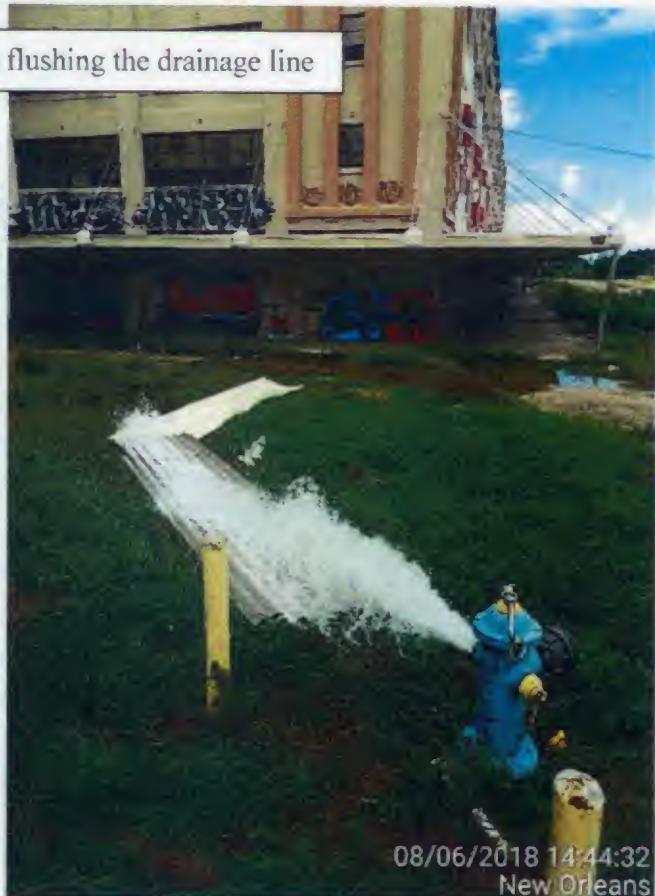
Hydrants inside Naval Base flushing the drainage line

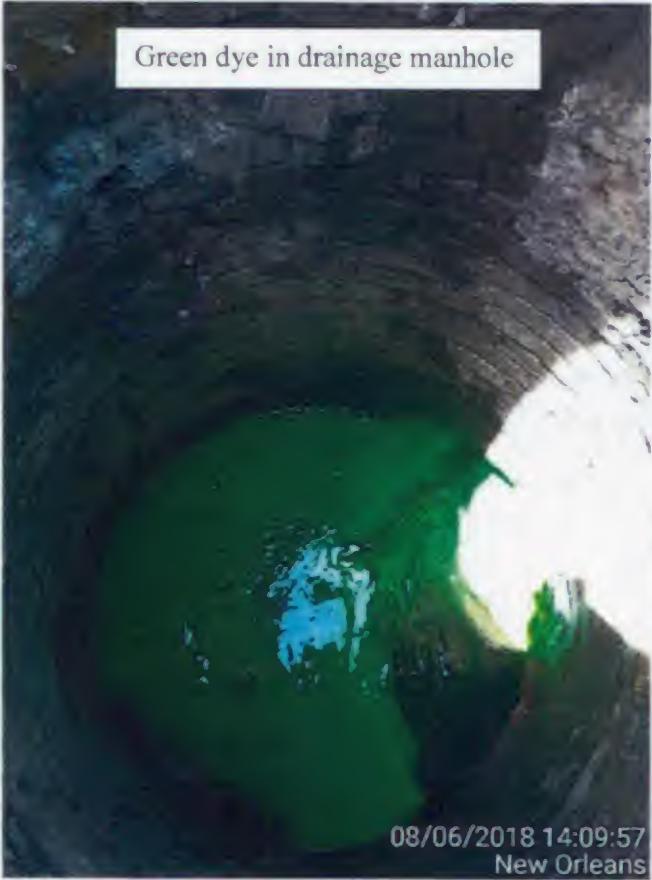
Green dye in drainage manhole

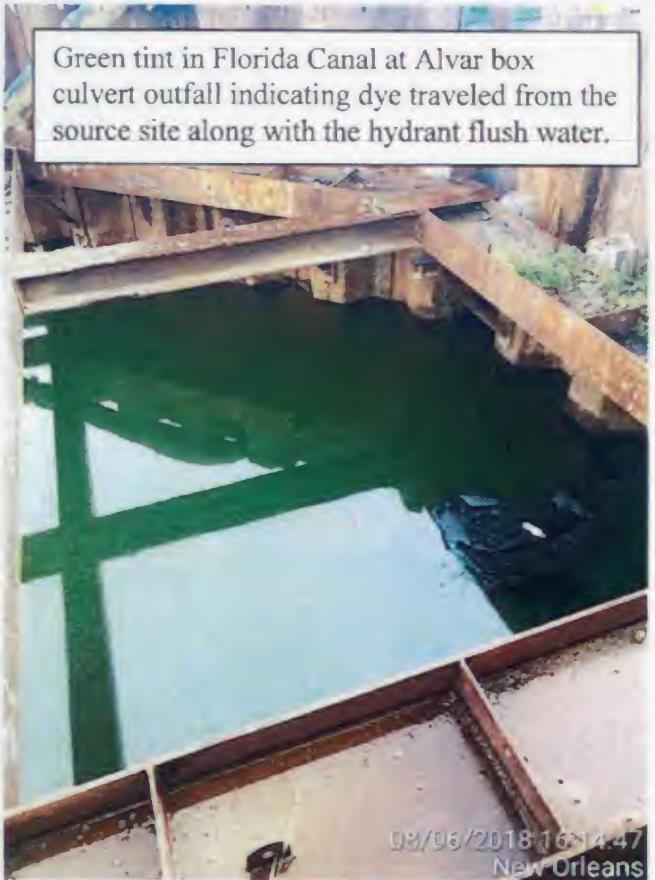
Green tint in Florida Canal at Alvar box culvert outfall indicating dye traveled from the source site along with the hydrant flush water.
